Rehabilitation of Corrosion Protective Coatings on Buried Steel Pipelines

By Michael Schad

In the following a short overview of coating materials to be recently rehabilitated and the respective solution will be presented. Special focus will be laid on the newly designed tape system DENSOLEN® AS50/R20HT by DENSO.

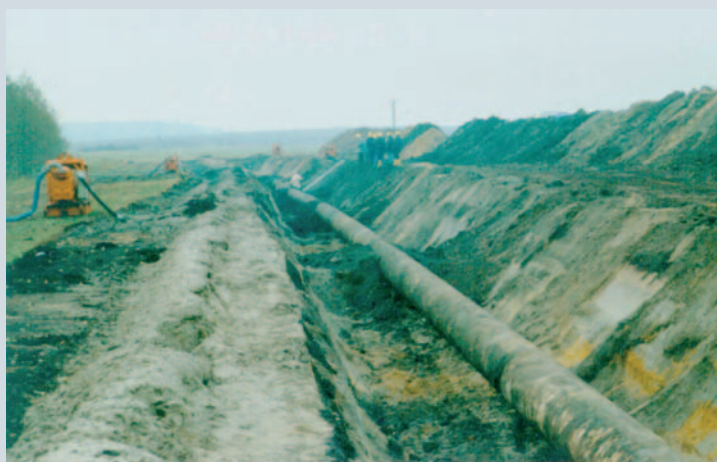
FIGURE 1: Bitumen coated pipeline

Coal tar and bitumen coatings (see **figure 1** and **figure 2**) are rather old types of coatings, but are still in use in some countries over the world, such as India. Very often these coatings got brittle, resulting in the formation of crevices and cracks and a significant decrease in adhesion to the steel surface. The risk of corrosion increases. Protective current voltages for old coal tar or bituminous coatings often exceed by far values which are acceptable for an economically operated cathodic protection. High protective current voltages result in the formation of H_2 and therefore increase the corrosion.

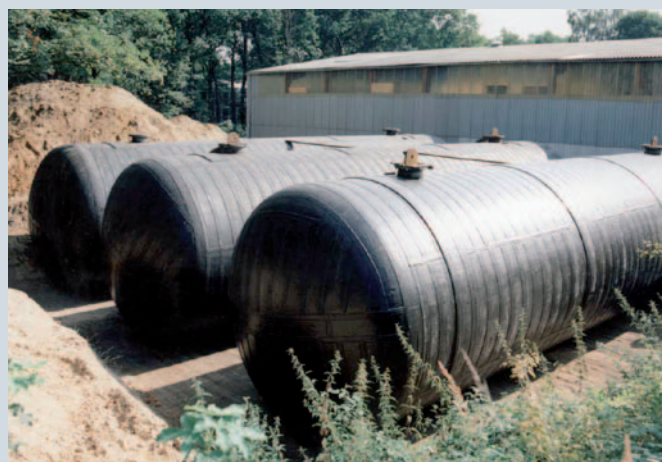
FIGURE 2: Bitumen coated storage tank

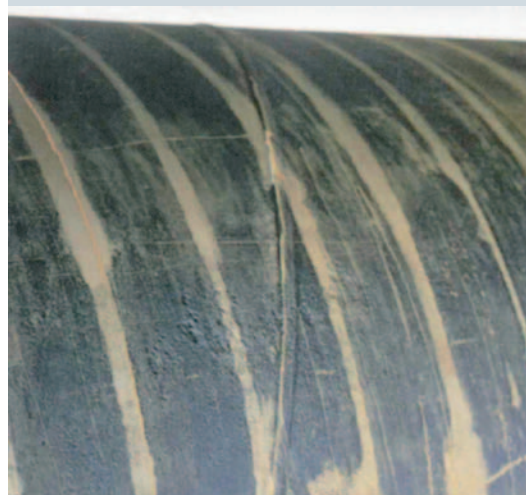
FIGURE 6:
Spiral corrosion

A high percentage of negative experiences with two-ply tape coatings in the past originate from the effect of spiral corrosion, which is shown in **figure 6**. In the remaining and clearly defined interface between the layers of a two-ply tape system micro channels exist, which facilitate a possible penetration path for water and oxygen.

After some time of operation of the pipeline, the incompletely sealed tape overlaps inevitably lead to spiral corrosion followed by complete undermining corrosion.

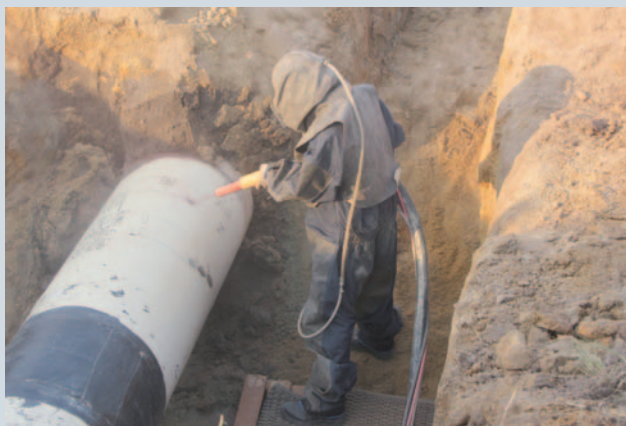
FIGURE 10: Blasting of defected areas

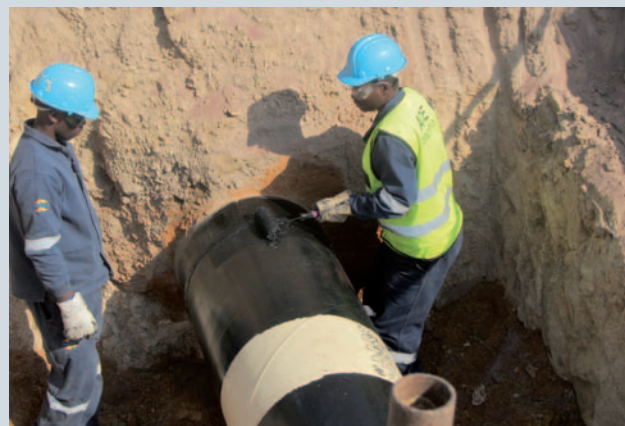
FIGURE 11: Application of primer HT

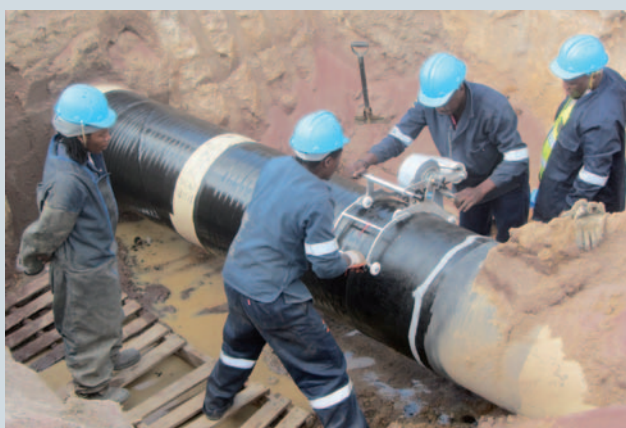
FIGURE 12: Application of inner wrap AS50

DENSOLEN® AS50 was originally designed for an “in-one-go wrapping”. With one wrapping turn, with only an overlap of 50%, the operator will achieve already the stress class B 50.

The new developed system DENSOLEN® AS50/R20HT (see **figure 12** and **figure 13**) is designed to combine an ease of application, economical pricing with excellent mechanical resistance and outstanding corrosion prevention, not only for larger scale rehabilitation projects.

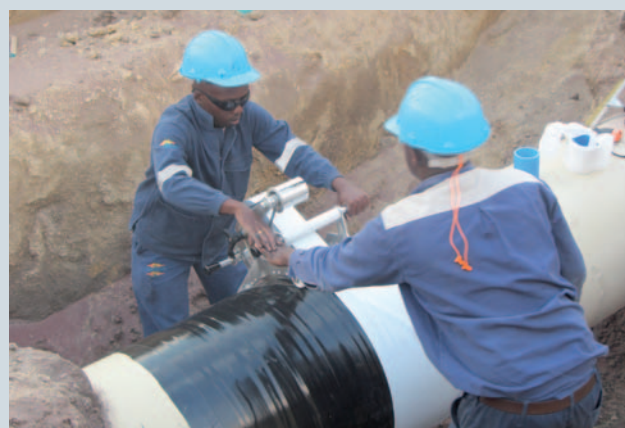
FIGURE 13: Application of outer wrap R20H

In combination with the white coloured two-ply outer tape DENSOLEN® R2OHT a structure will be applied which will by far exceed even the highest stress class C 50 according to EN 12068.
