A supplement to World Pipelines – Volume 23 Number 8 – August 2023

BITUMEN VS BUTYL: WHICH IS SUPERIOR?

Thomas Kaiser, Managing Director, DENSO Group Germany, considers whether PVC/bitumen or PE/butyl rubber is better suited for use in corrosion protection tapes.

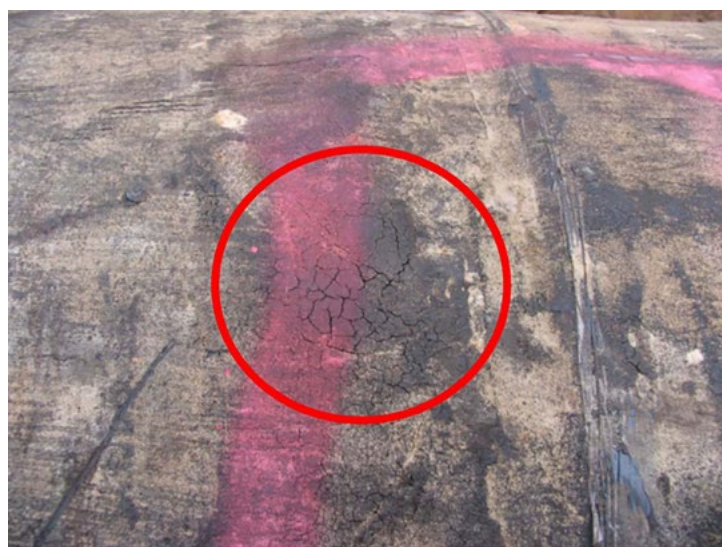
Figure 2. Cracks in the coating due to aged bitumen.

In summary, bitumen's weakness is its structural ageing, as shown in Figure 2. The speed of the ageing process depends on the temperature and the source of the crude oil. The addition of additives (polymers) can slow down the process but can't stop it altogether. The result is a porous coating and cracks.

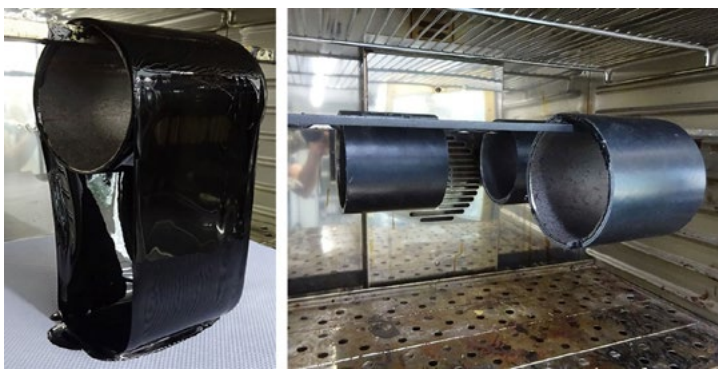
Figure 4. Material behaviour of PVC/bitumen tape (left) vs PE/butyl rubber tape (right).

The different behaviour of the different material combinations at higher temperatures has been recreated at 75 °C (167°F) during tests: the PVC/bitumen tape no longer offers any protection after just 26 hours, whereas the PE/butyl rubber tape remains dimensionally stable and in perfect condition even after 100 days in storage (see Figure 4).
